ASH BARTON BRAUNTON DEVON

Results of a Desk-Based Assessment
and
Historic Building Recording

Report No.: 100427
Date: 04/05/2010
Authors: T. Green
C. Humphreys
R. Waterhouse

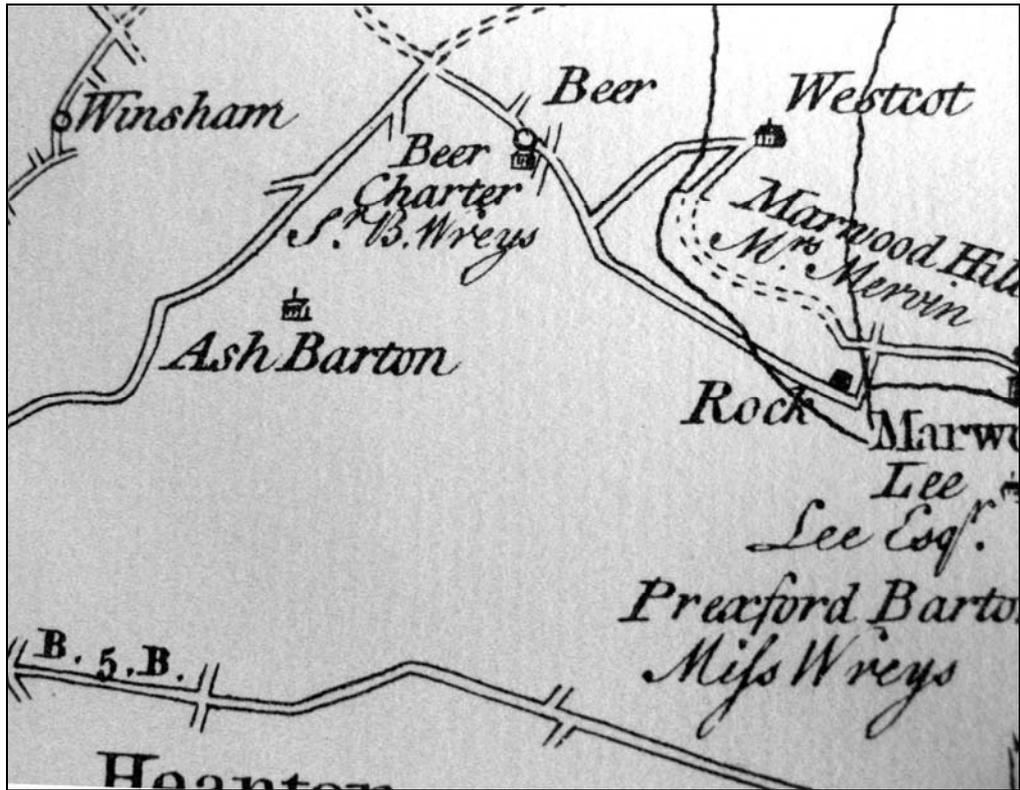
Figure 2: Extract from Benjamin Donn's map of Devon, 1765. (NDRO)

The earliest map available to this study is Benjamin Donn's map of Devon, 1765 (Fig. 2). This records Ash Barton, but without any subscript personal name, clearly indicating that at that date this was not the residence of a 'gentleman', but was presumably a tenanted farm as we find it in the Land Tax record of 1780.

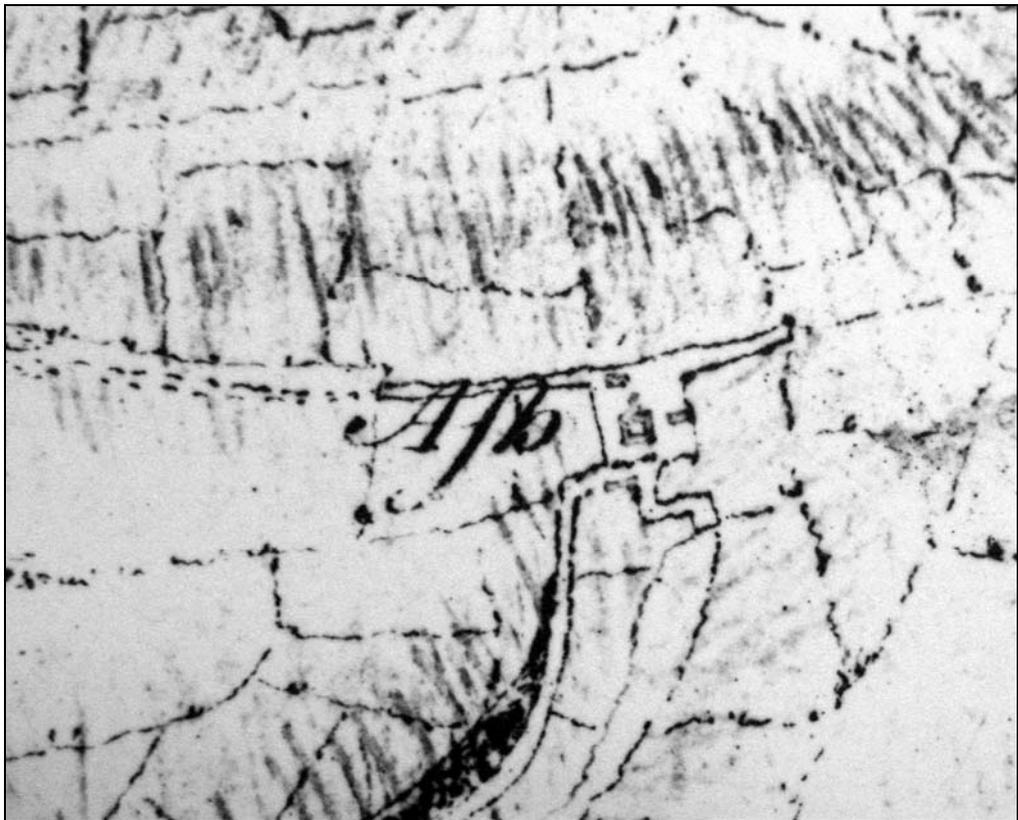
Figure 3: Extract from the Ordnance Survey Surveyor's draft map, 1805. (WCSL)

The Ordnance Survey Surveyor's Draft map of c.1805 (Fig. 3) published as the one inch to the mile map of 1809, is the first to provide any detail, even if it is somewhat schematic. Naming the settlement simply 'Ash', it shows a courtyard arrangement with outbuildings to north and east. Access at this date appears to have been gained principally by way of what is now Ash Lane, running south to join the Old Barnstaple Road.

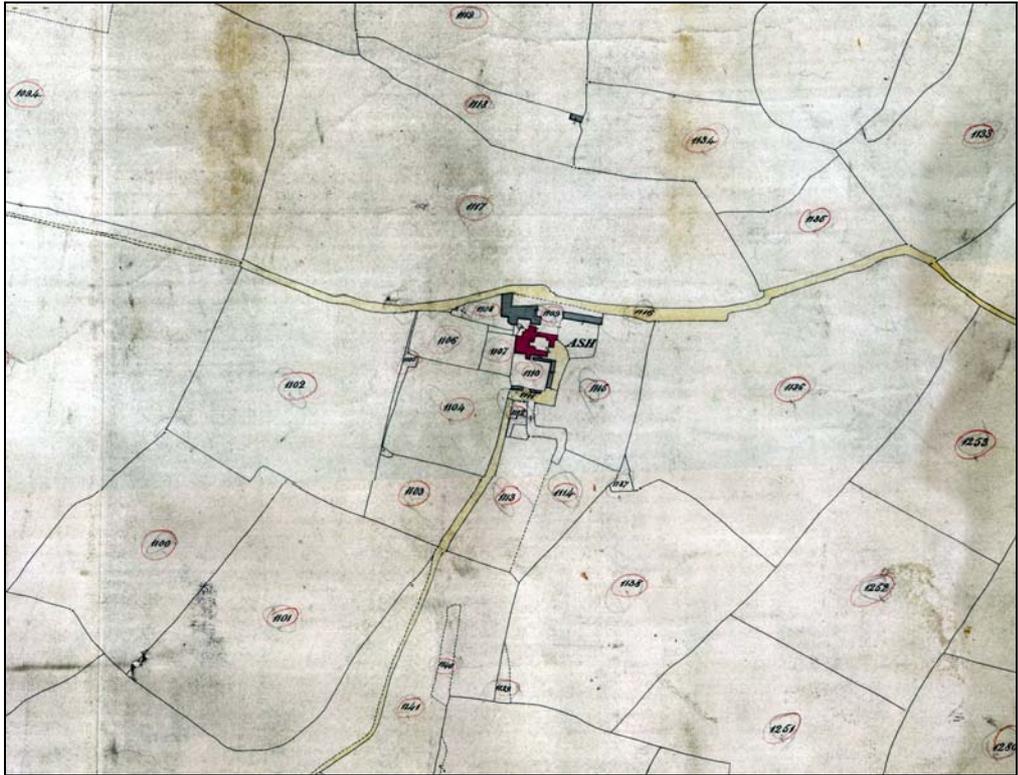
Figure 5: Extract from the Braunton Tithe map (sheet 2), 1840. (DRO)

The best early cartographic account is provided by the Braunton tithe map of 1840 (Fig. 5 & 6). From this the number and configuration of the buildings existing at Ash at that date is clear. The residence, coloured red on the map, is shown as a complex structure surrounding an open court yard and with, on the south side, an east west range with a projecting bay overlooking what in the accompanying tithe apportionment is described as 'Front Garden' (number 1110 on the map). 'Offices' and ancillary buildings are coloured grey on the map. These include, to the north west, a large structure with two principal ranges forming an L, on the south side of which is a projecting bay which probably contained a horse engine. To the north east is a long range on an east west axis.

To the south of the residence an L-shaped structure lies along the northern and eastern borders of the 'Front Garden', the north range extraordinarily close to the south frontage of the house, apparently obscuring any view. On the southern border of the garden are two small rectangular outbuildings. West of the 'Front Garden' is 1107 'Back Garden' and to the west of this is 1106 'New Orchard' with 1104 'Great Orchard' to its south. South east of the house is 1115 'Gratton Meadow' and 1113/1114 'Hoss (sic) Plot'. If 'hoss' represents 'horse', then the name makes sense as there is what appears to be a wide path leading from 1113/1114 to 1111 'Horse Pond and Yard'. Immediately to the south of the latter is 1112 'Lower Shed and Yard'. In the corner of this small area is a square which probably should be coloured grey as it probably represents the 'shed'.

A high yard wall of clay-bonded, sandstone rubble similar to the barn continues the south side wall of the barn to the west and then to the north. This structure was part of the barn prior to it being truncated in the late 19th century (see Figs. 5 & 6). The south wall has a vertical break at the east end that is roughly repaired in rubble and shows where the east end wall of the barn was rebuilt.

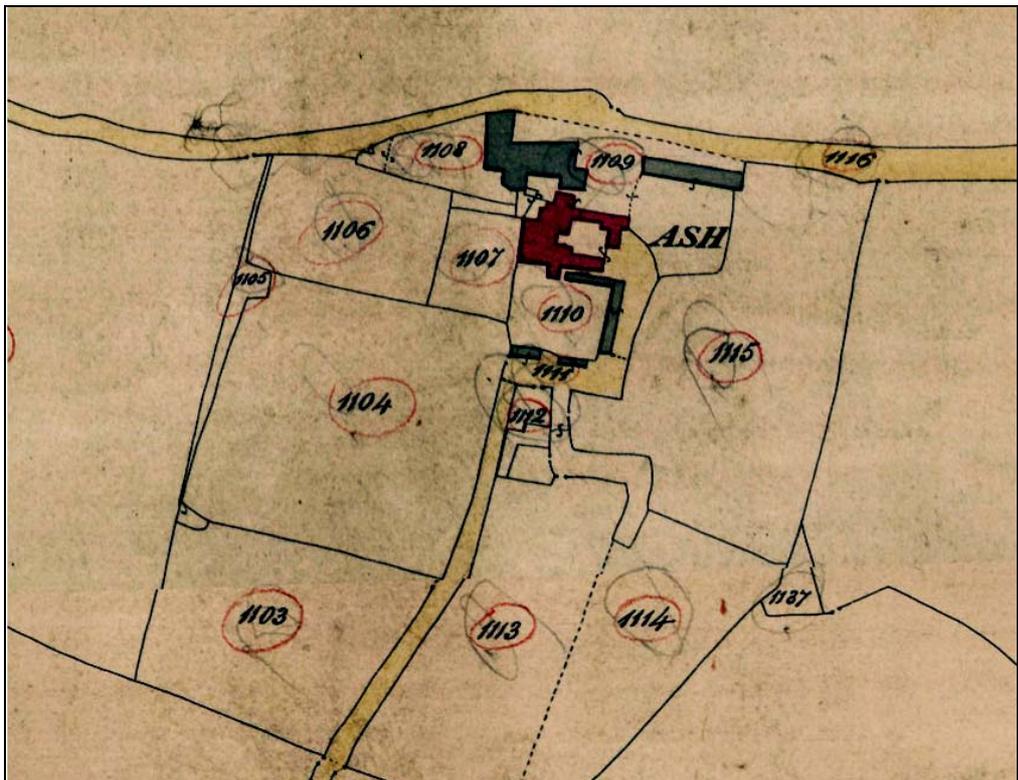
Figure 6: Enlarged view of Ash from the Braunton tithe map.

The principal approach to the house again appears to be from the south by way of what is now Ash Lane. The approach leads to the courtyard area enclosed by wings of the residence. Otherwise the approach is from the east (from Pippacott) and west (from Braunton) accessing the north side of the complex.

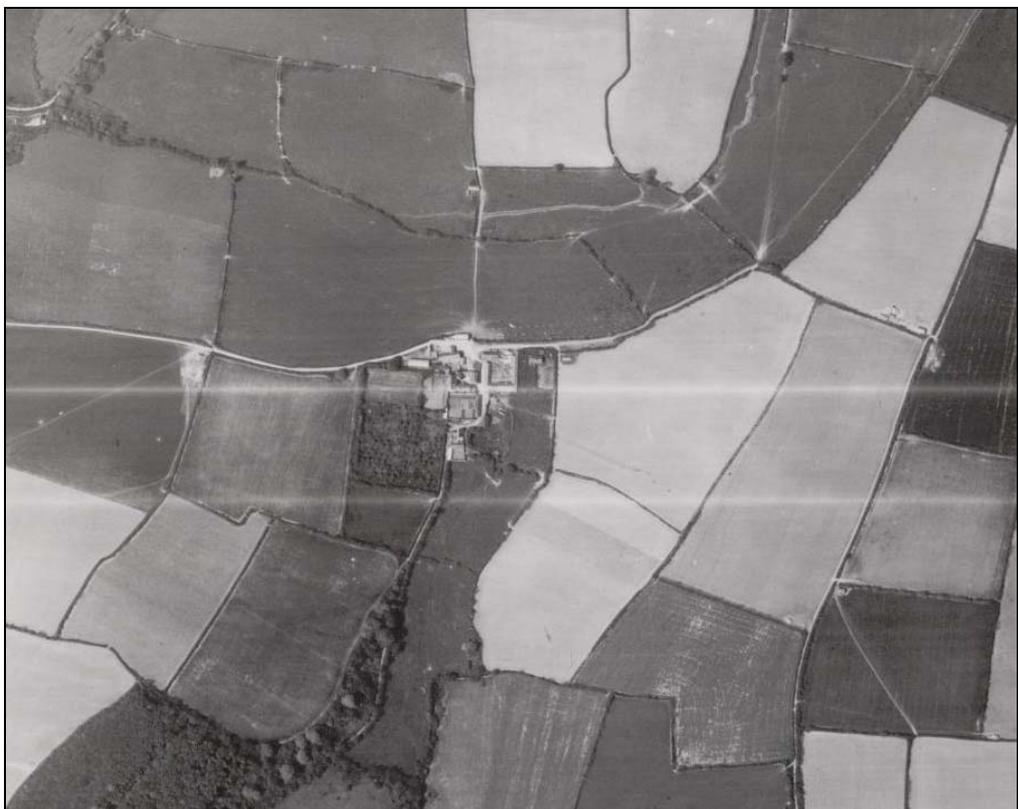
Figure 9: Aerial photograph taken May 1946. (NMR/DCHES)

An aerial photograph of 1946 (Fig. 9) may indicate the addition of a long building to the north west, but otherwise suggests little change during the first half of the 20th century. The orchards appear to be maintained to this date, but are now (2010) gone.

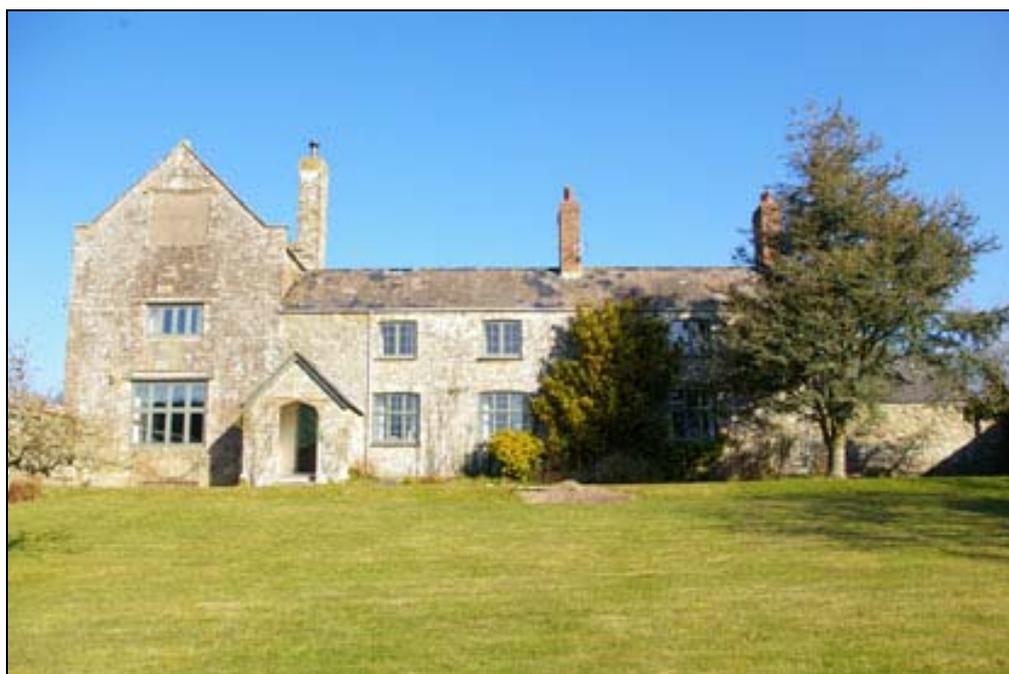
Figure 10: Ash Barton viewed from the south.

The south range is of two storeys with a ridged slated roof, in random squared rubble with a single storey gabled porch to the left front. There are two substantial brick stacks, an axial stack to the right of centre, a second to the right gable. The west end of the roof abuts a substantial two and a half storey gabled cross-wing of extremely high status and apparently of 16th – 17th century date. The south gable of this west wing is of extremely high quality coursed ashlar and projects very slightly forward. With three substantial windows, one to each floor (the first floor window was possibly narrowed in the 17th century?), the ground and first floor window have hood mouldings and segmented relieving arches. The attic floor has a large, square, blocked window with a moulded surround and hood moulding, a segmented relieving arch with a date stone of 1665 above (slightly off centre). The gable above has shaped capping stones on shouldered bases with a cruciform finial of carved stone at the top.

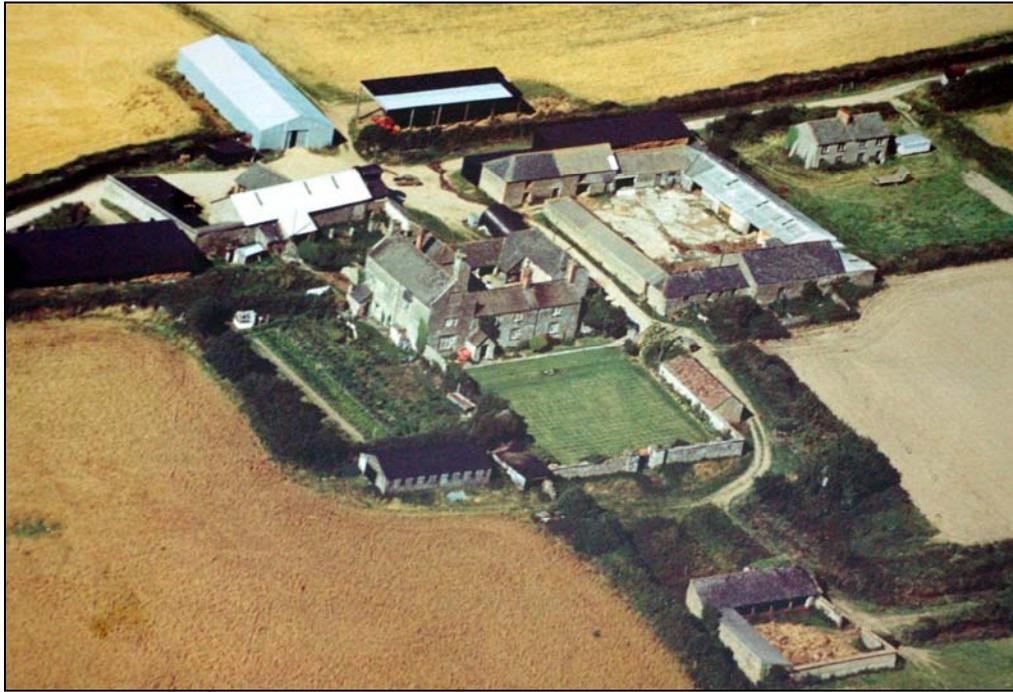
Figure 11: Late 20th century aerial photograph of Ash Barton. (Courtesy of S. Daukes)

Ash Barton is a small courtyard mansion of 16th – 17th century appearance facing south and west across terraced formal gardens of unknown date (see Fig. 10 & 11).

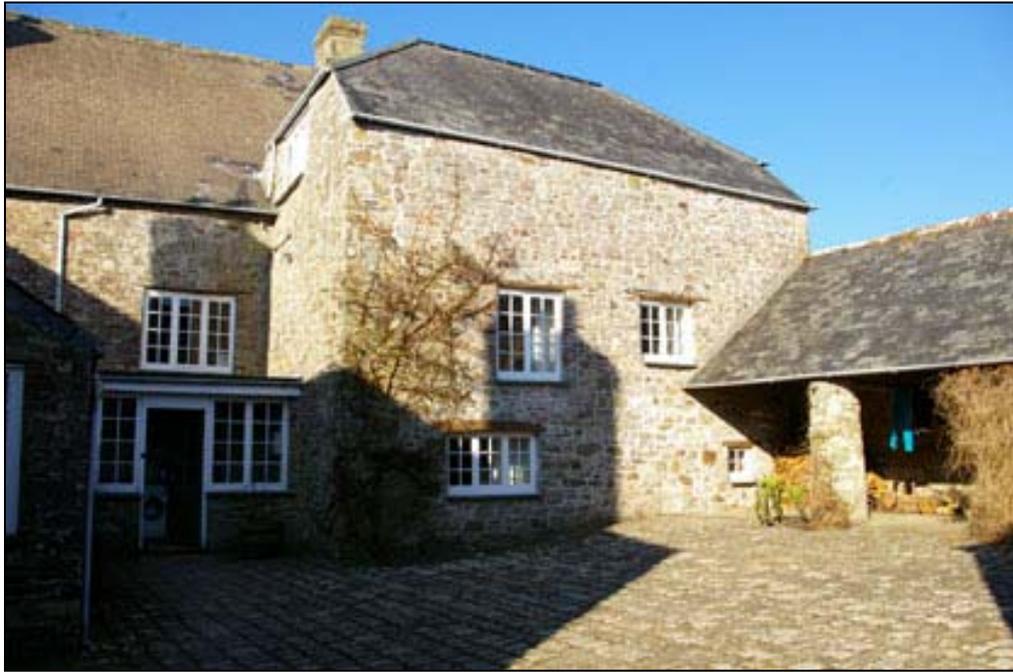
Figure 12: View of the courtyard showing the former detached block, from the south east.

Abutting north-east corner of the kitchen/chamber block is a stone and cob north wall enclosing the yard, which also abuts an earlier wall at the east end. The wall is of random stone rubble to waist height and rising above the door, situated to left of centre, and continuing at lintel height to the end of the wall. Above this is cob, in two and a half lifts, with some brick and concrete repairs to the wall top and to the upper east end, with slated ridged capping. (The 'Chapel' to the north east is described separately below).

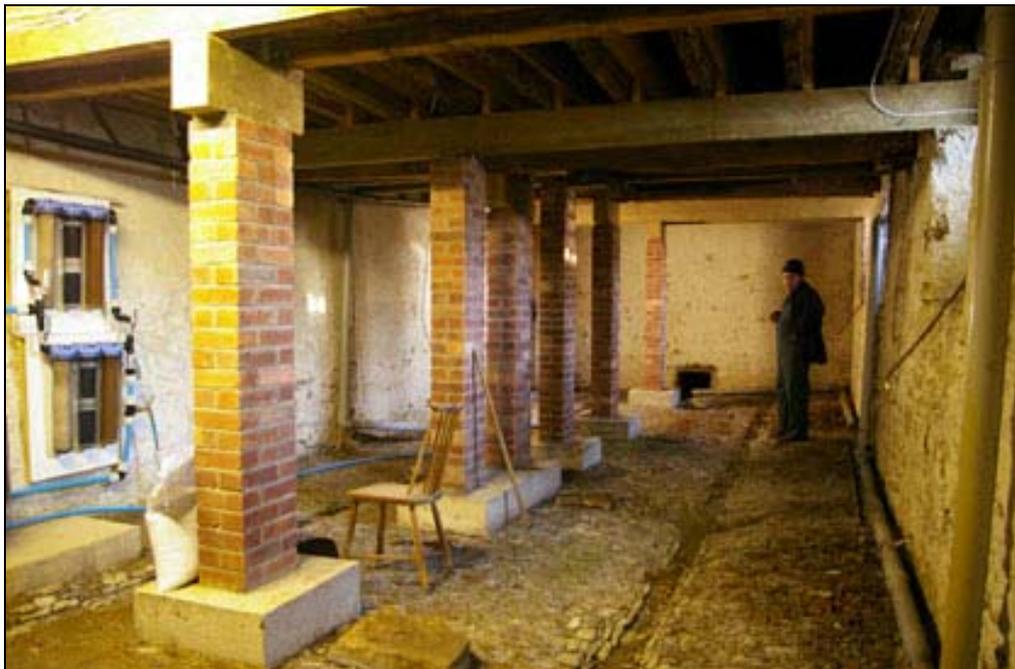
Figure 13: The west side of the cellar viewed from the north.

Wine cellar under the 17th century cross-wing. (Fig. 13 & 14)

Ceiling: A sequence of two transverse beams chamfered with stops, with axial joists, unshaped but with evidence for lathe and plaster on the underside and on the elm boards above. The beams are chamfered and stopped, the design being possibly of early to mid 17th century date. A sequence of stone pads in the floor suggests that vertical supports had been present in the past. These have been replaced by substantial modern brick pillars.

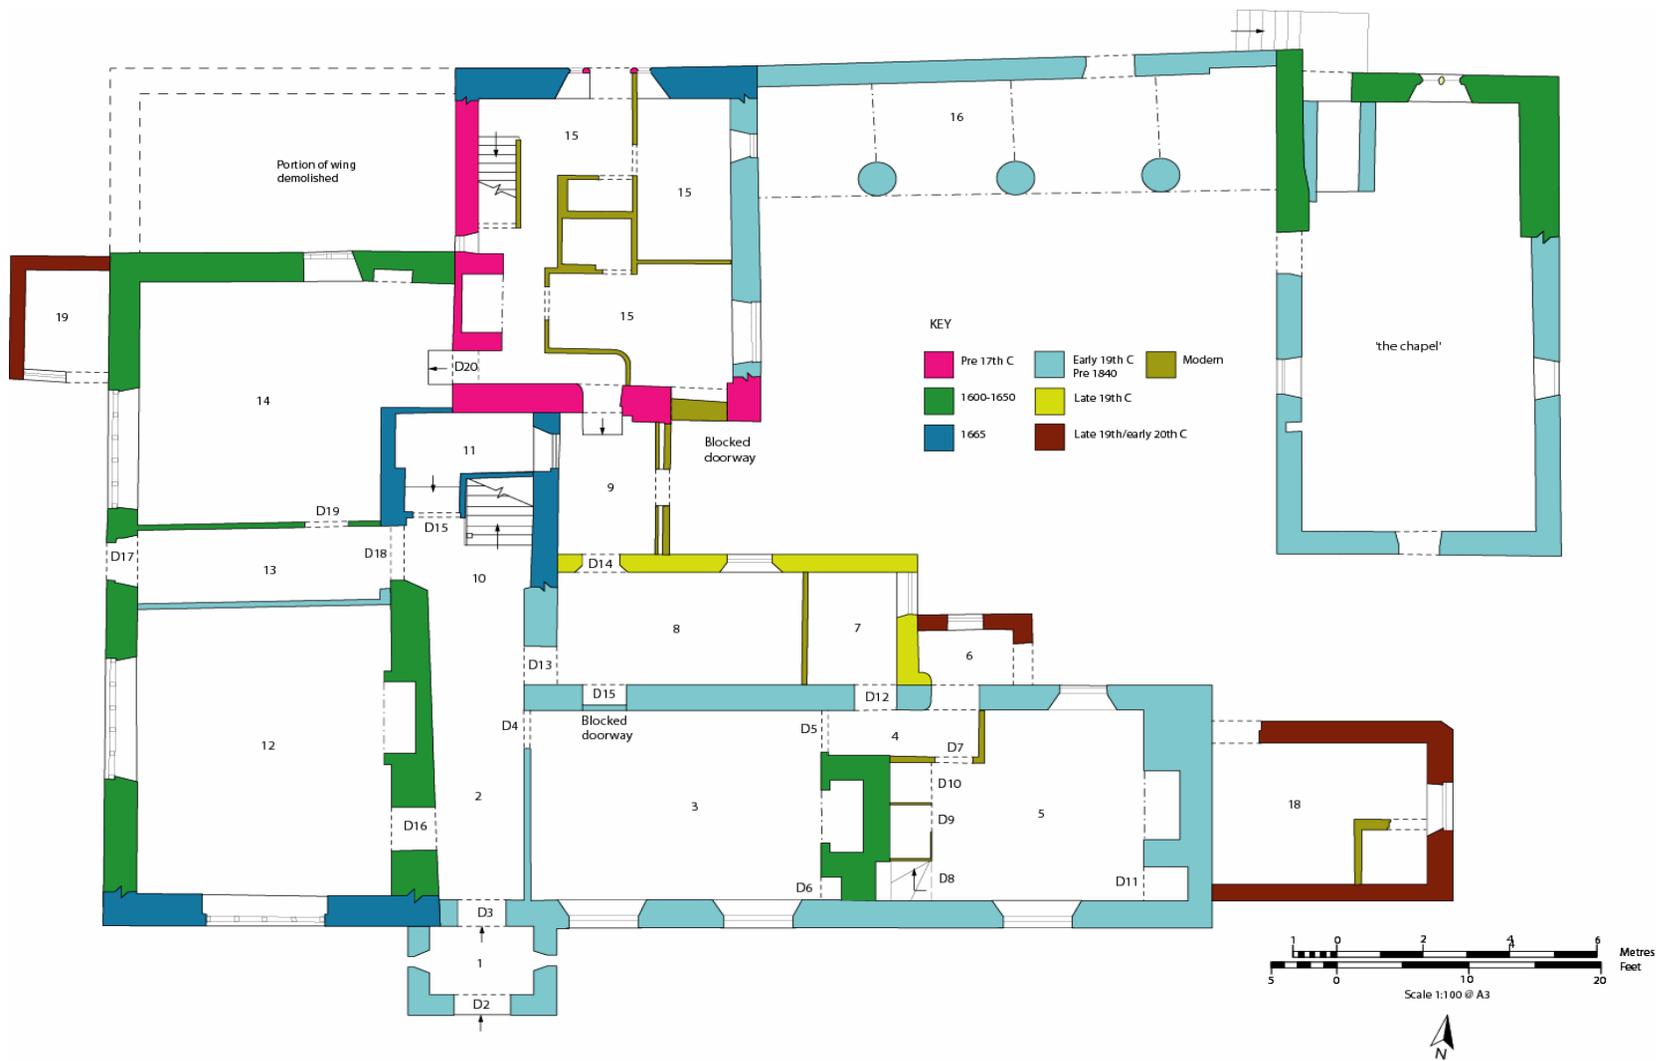
Figure 15: Ground floor plan showing developmental phasing.

3.3.2. Ground Floor (See Fig. 15 for ground floor plan)

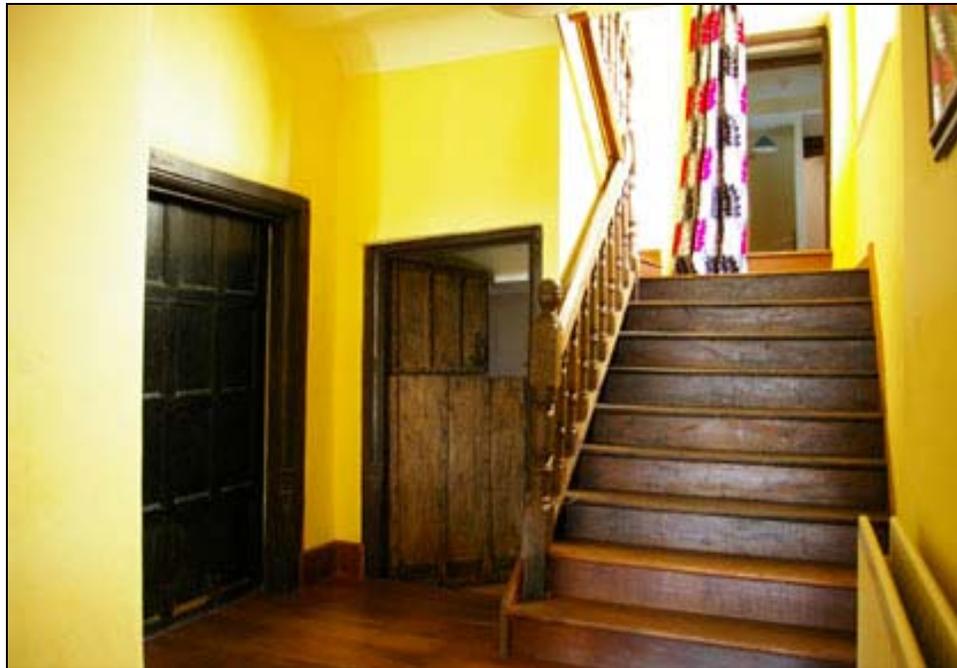
Figure 16: The stairs rising from the rear of the hallway (10) viewed from the south.

Stair: A straight run up to the north from the ground floor to a quarter landing; with a single step up to the second quarter landing to the west, from which two straight runs to the first floor landings run up to the north and south. That to the south has a framed balustrade overlooking the stair, with a turned newel post at either end and turned balustrades between, with square cut hand rail with a shaped top. The newel posts have acorn capitals. This section of balustrading has been removed at least twice, with a sequence of blocked mortises in the underside of the handrail which do not relate to the current balustrade spread, the mortises of which have been re-cut. The eastern end baluster and part of the hand rail are modern. The balustrade continues in this form down the eastern side of the top flight and is scarfed into the handrail continuing down on the western side of the bottom flight, the details of which are the same. With a shared newel post at the quarter landing rising through both balustrades as a single timber. The undersides of both sloping balustrades are squared timber, the uppers having chamfers. The lower skirting to the sides of the flights are all modern and much of the stair framing has been dismantled and re-erected in the recent past, as has the handrail of the upper flight.

The north flight from the quarter landing has a detached portion of balustrades up its west side (details as above), but as this is against a modern partition its location here must be regarded as suspect. The treads and risers of all three flights, although of oak and possibly 17th century in date, appear to have been dismantled and re-erected as all the side planks are modern.

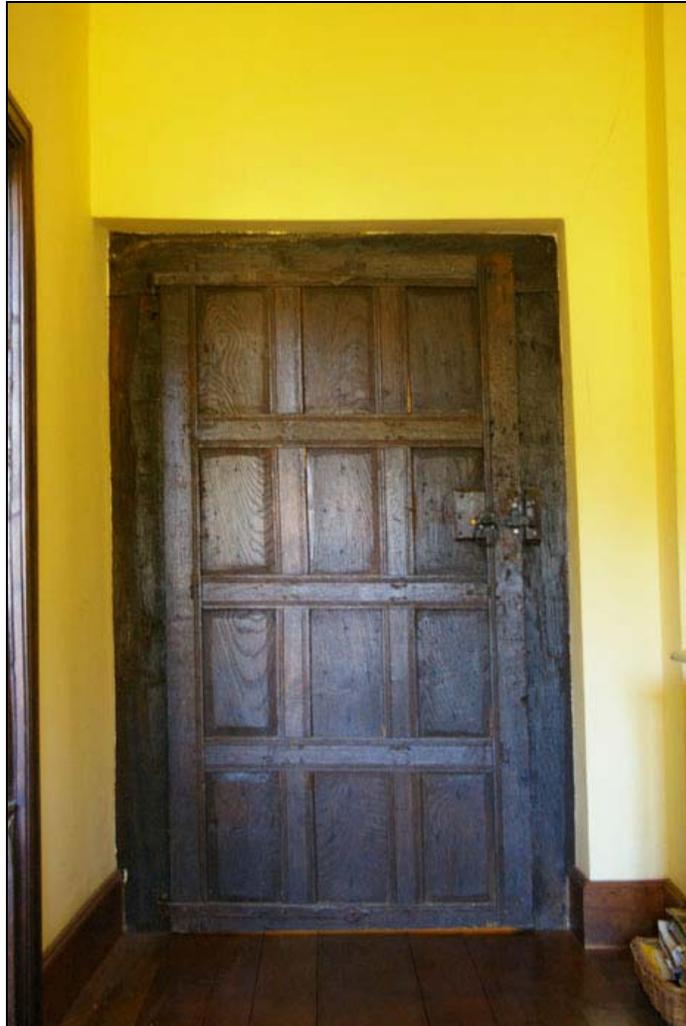
Figure 17: The door (D18) viewed from the west.

Doorways: D18 – door to the west hallway (13). See room 13 for detailed description of this door. However the front of the frame faces into room 10 and is designed to be seen from there.

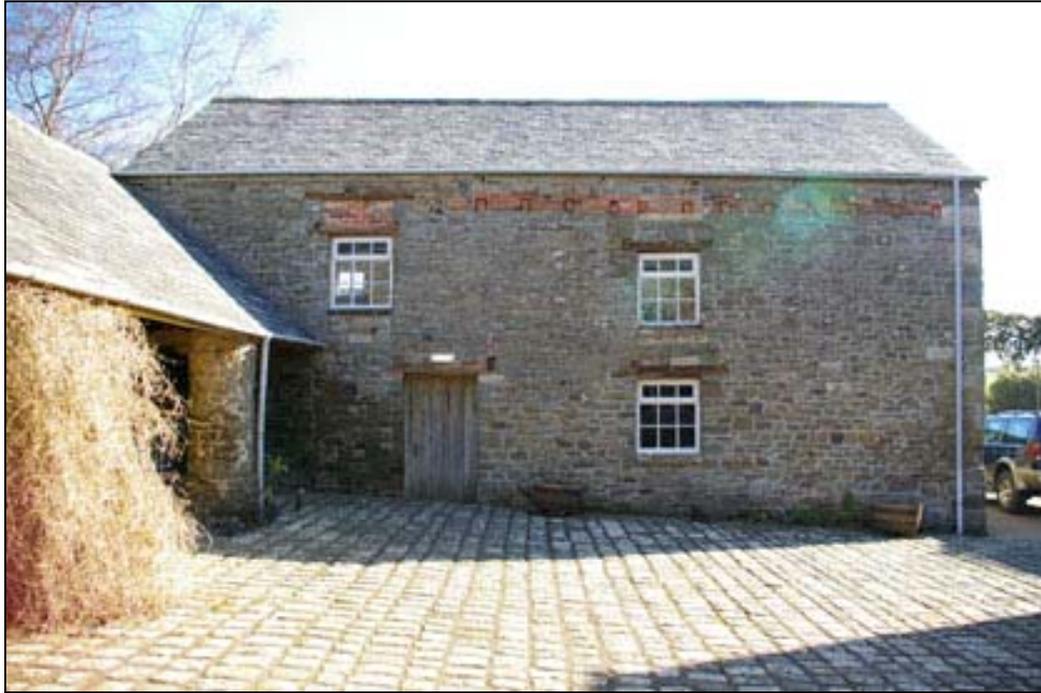
Figure 20: The Chapel viewed from the west.

A three storey detached building set on a north-south axis to the north-east of the main range of buildings. This building is constructed in two distinct phases and is composed

of a 17th century two storey building to the north to which a three storey section was added to the south replacing some of the earlier structure in the 19th century.

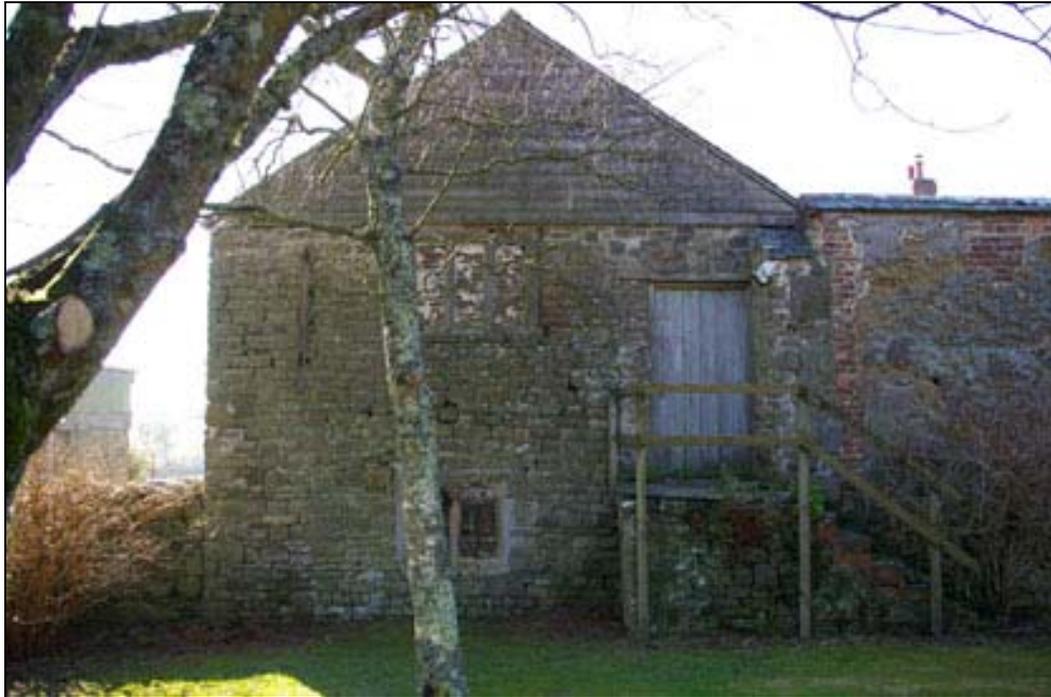
Figure 21: The north gable viewed from the north.

ground floor at the centre and with two windows in line above to the first and second floors. The upper part of the gable is infilled with weather boarding and appears to have a warehouse hatch layout.

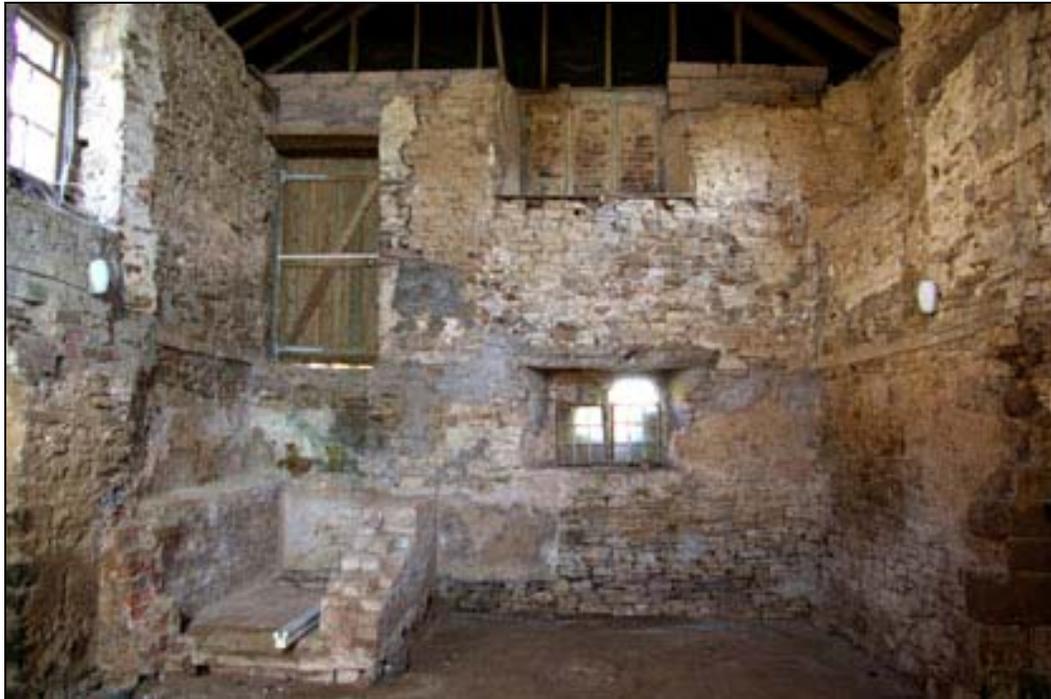
Figure 22: The north wall of the Chapel viewed from the south.

Windows: The window to the north is a two light casement with 3 centre arches, hollow moulded mullion and surround, triangular inset spandrels and chamfered sill. A pair of hinges on either side were for shutters which are now missing. The ferramenta is described with the external description but the window was never glazed (see Fig. 22).

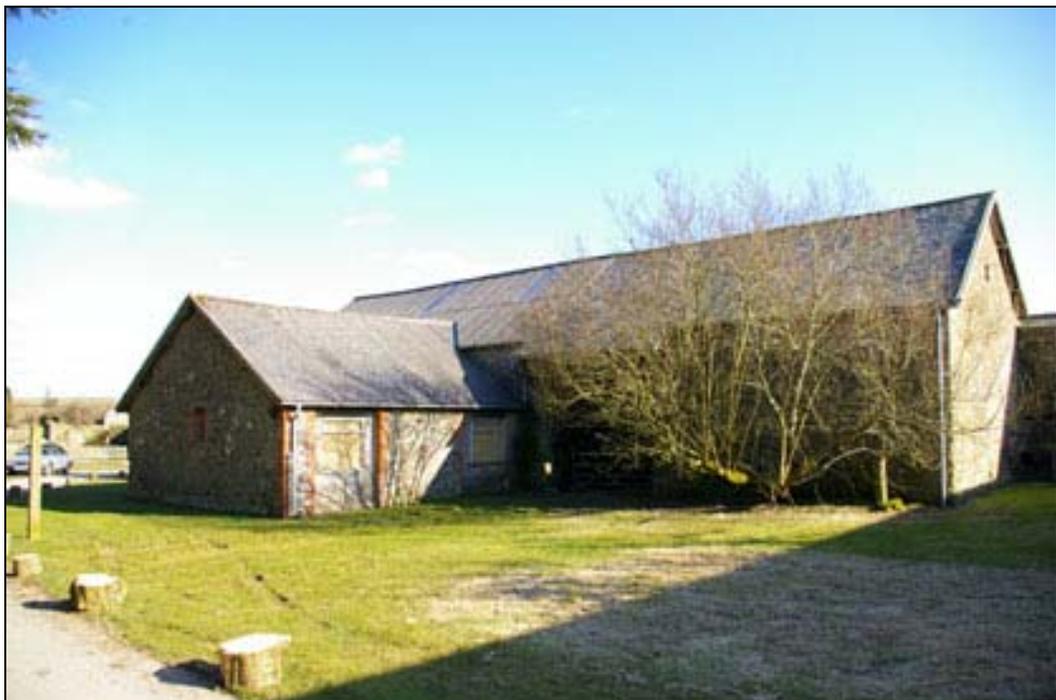
Figure 24: The south elevation of the Barn viewed from the south west.

Walls: Of semi-coursed sandstone rubble, lime mortared and flush pointed with later pointing episodes in cement. With various blocked joist holes for a first floor structure in the eastern part but not the western. The east end of the wall of

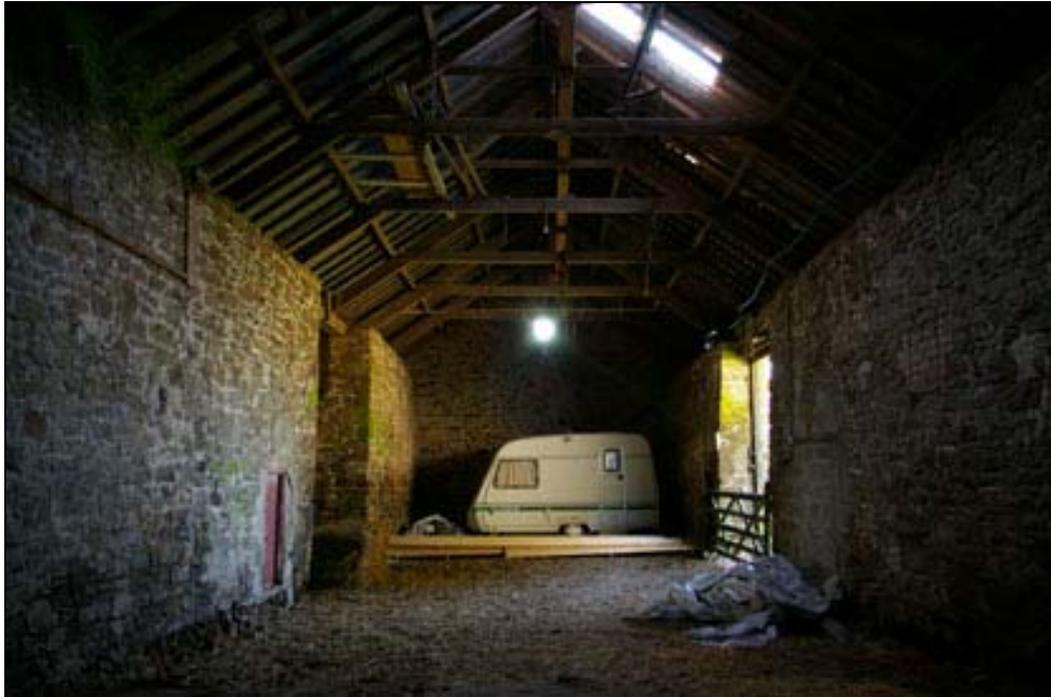
Figure 25: The interior of the Barn viewed from the west.

Roof: Eight A-frame trusses with lapped apexes and collars, with 2 purlins per side on the backs of the blades, with all joints coach bolted. The trusses and

purlins probably date from the late 19th century, the common rafters, clasping the ridge plank are probably later.

the barn appears to be secondary with short stubs of masonry constructed into the north and south walls.
